2017

Project Completion List

Lee Island, Big House

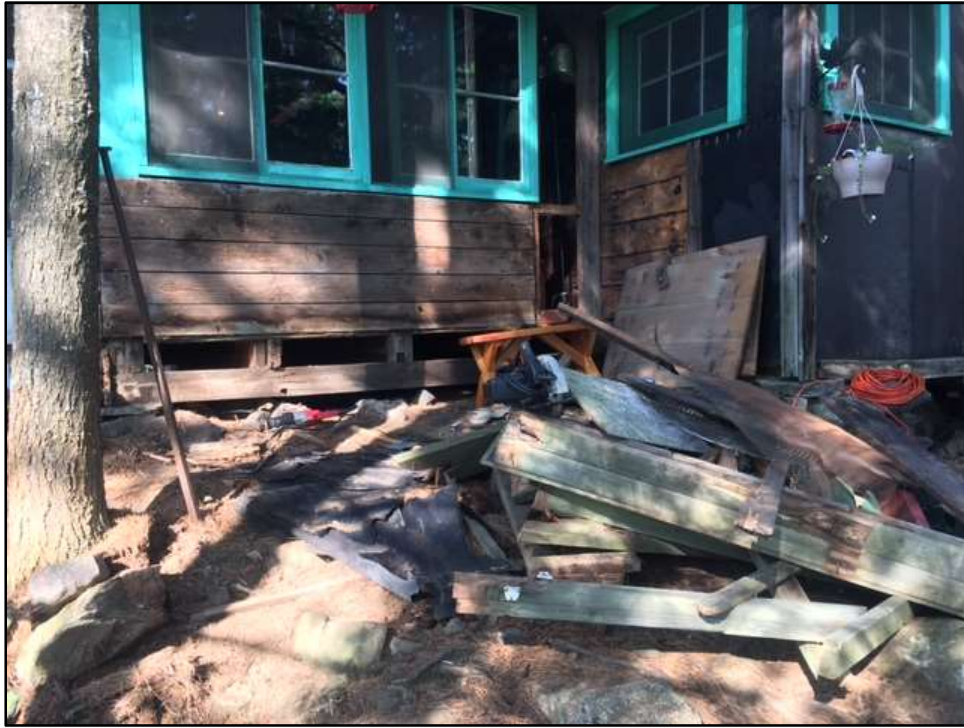
Deck and stairs removed from BH kitchen. Circle shows area of replaced siding.

The steps and deck to the side entry of the kitchen were removed and the newly exposed wood was evaluated for integrity. Several poorly installed siding boards were eliminated and replaced. Most of this wood has lived behind tar paper with no one really knowing what lay behind the black facade. Don't look, it's scary. I do not have an immediate plan to replace the steps as there are several options to choose from but the outside sheathing is now ready for some proper siding. For added security I will likely replace the aluminum storm door with an exterior grade entry door, similar to what is installed on the storage building, once a design is agreed upon at the owners meeting.

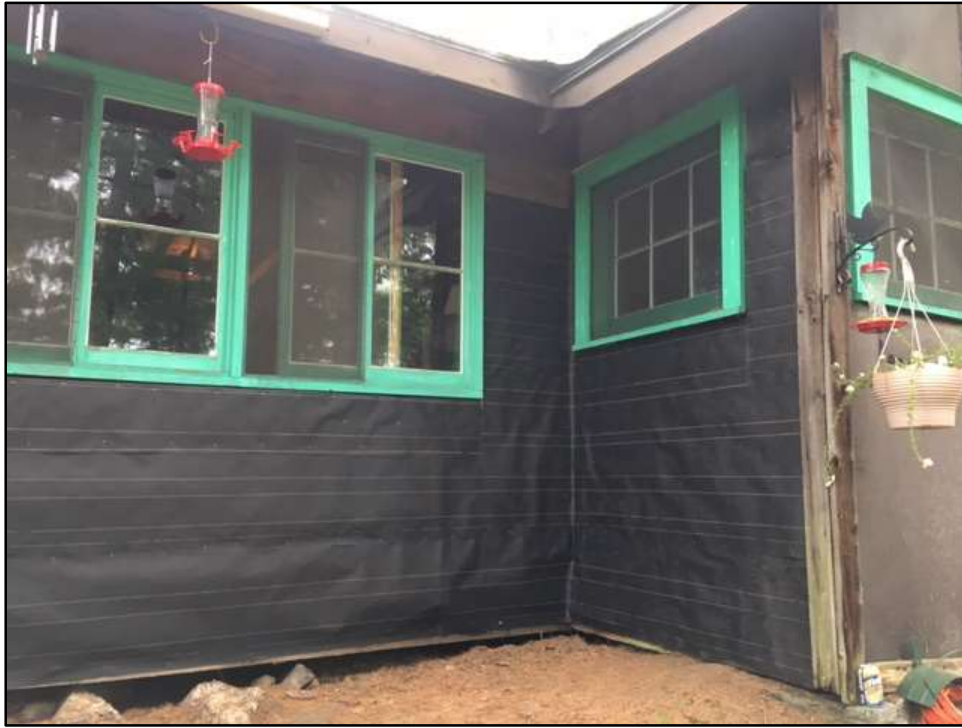
Tar paper replaced after siding was installed. This area will have exterior siding.

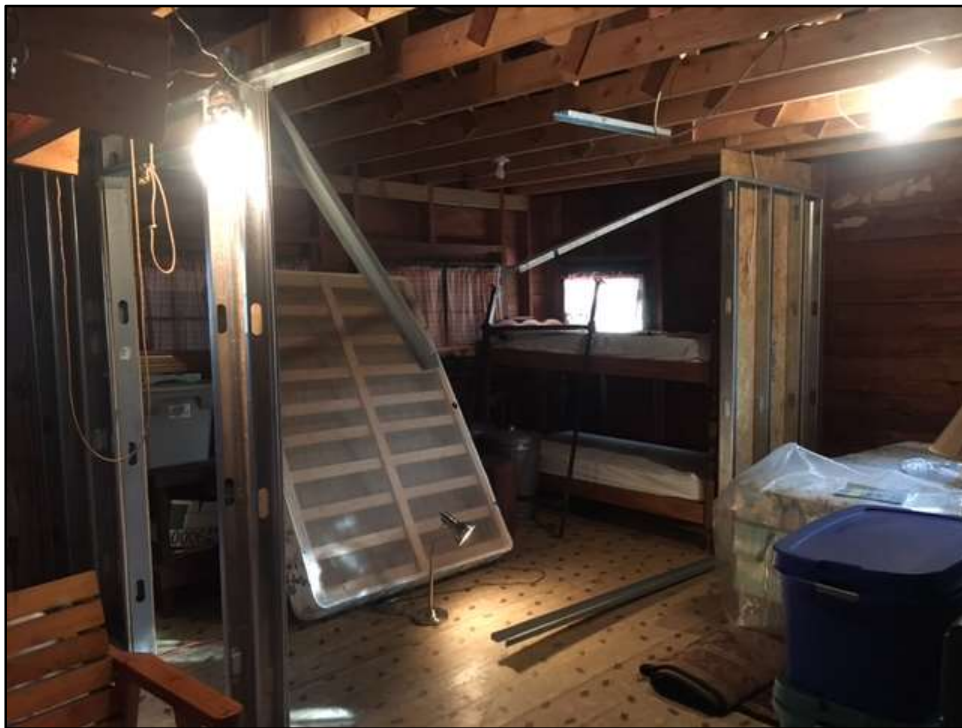
Partitions in the process of being removed from BH living room.

The partition, added to the Big House living room which divides the space for two additional bedrooms, was removed. This space will now be used as originally intended. I would like to install a drop down attic ladder in one of the two original bedrooms and eliminate the awkward and dangerous steps to the loft. Along with some other envisioned changes to this space, the Big House will be returned to its former glory as a family gathering place.

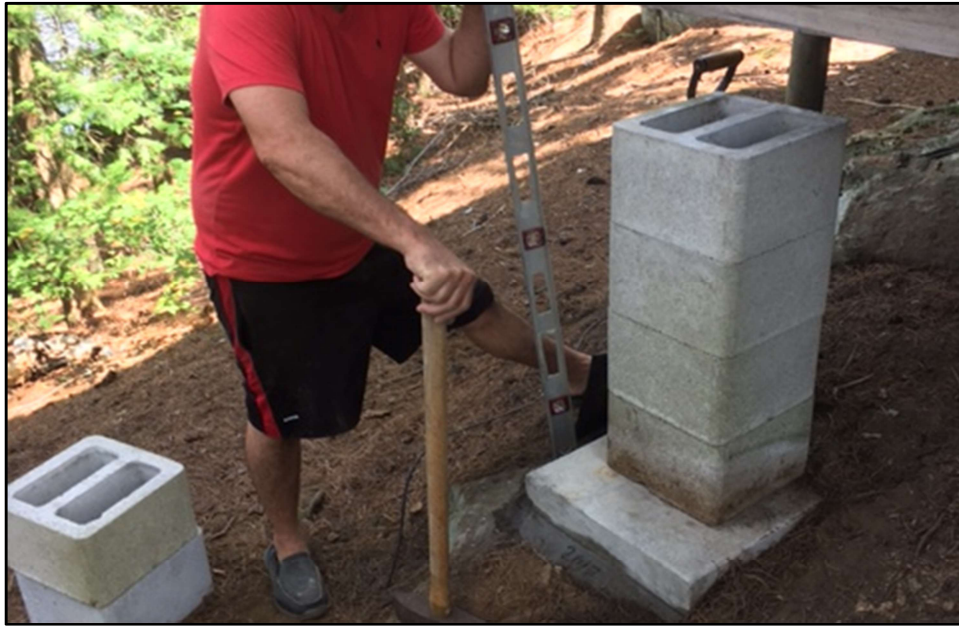
Cement pads and cinder block installation under BH kitchen.

Work continues on the Big House remodel with several accomplishments in 2017. Leveling the building was started which required pouring footers for the kitchen support system. Two cement support pads were poured and cinder block columns were erected to brace the main beam. Multiple additional columns are needed under the kitchen and several under the main house to shore up the structure. Ideally, a support system of steel beams similar to what is under the Little House addition would be used but this would be expensive and labor intensive. Unfortunately, there is no easy way around this job and the final horizontal level may be a little shy of perfect.

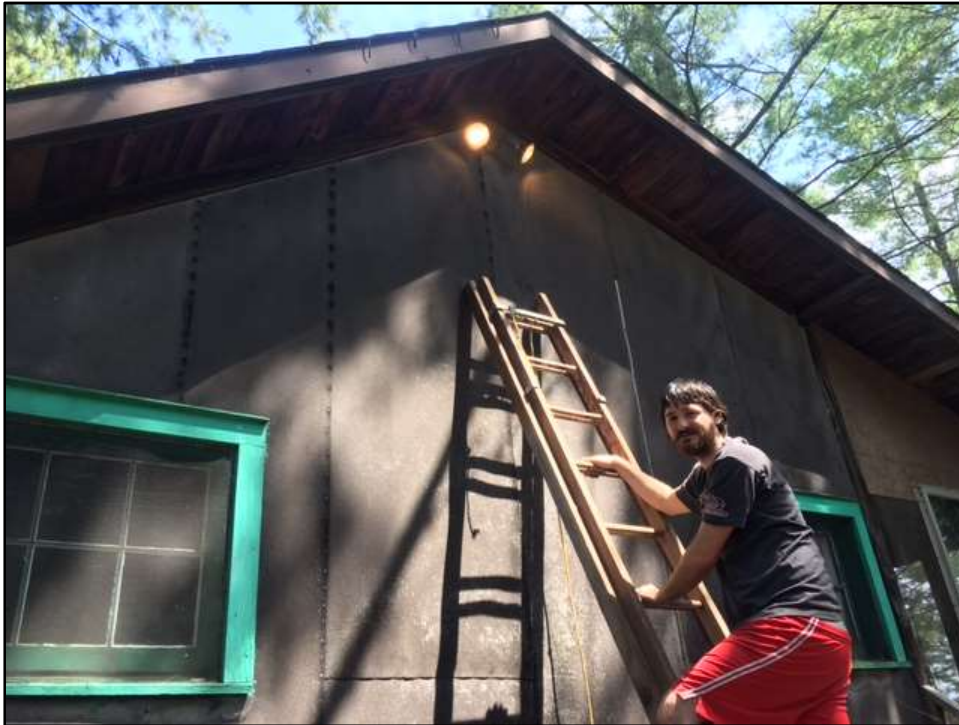
Ryan installing outside lights on BH gable

Ryan added a security light on the gable end of the Big House, lighting the pathway from the top of the hill to the kitchen side door. A much needed and nicely done job; however, the electric used to light the path up the hill was taken out by a birch tree and is not working. This is not a major job but one that will take some time to re-establish.

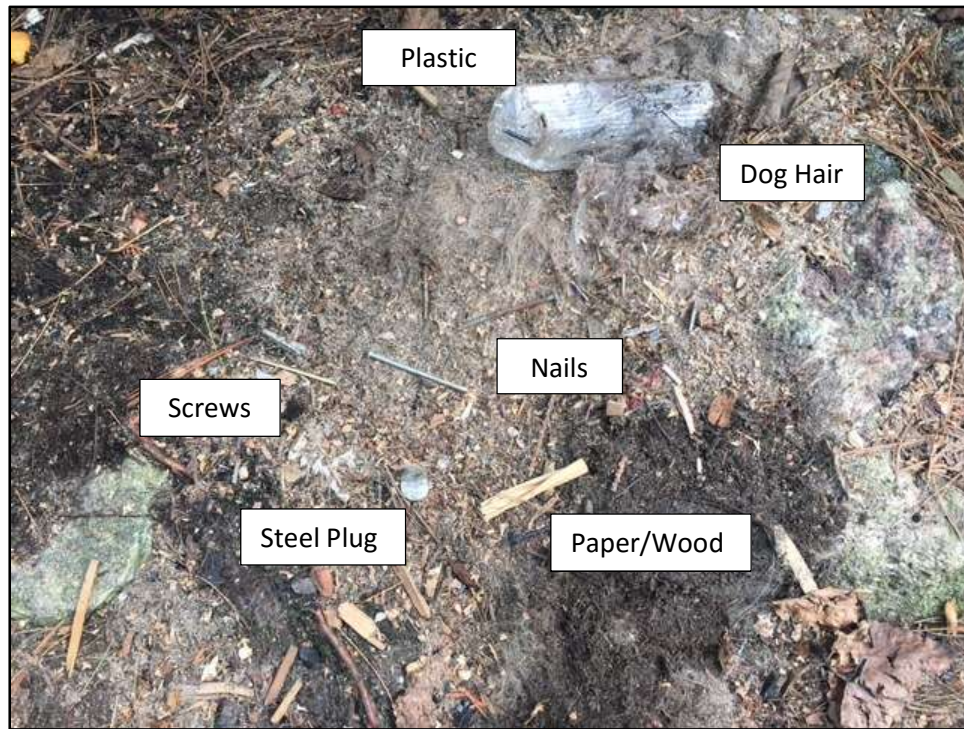
ShopVac debris on pathway adjacent to kitchen steps at BH. LH had similar debris on the path outside the front steps.

* When we arrived back to the islands in August a couple issues were noted that need to be addressed. First, the pathway in front of the Big House and Little House immediately adjacent to the entry steps was inexplicitly littered with garbage from the ShopVac. Included in this debris field were nails, screws, candy wrappers (skittles), wood, metal, and plastic rubbish and dog hair. In the future ShopVac contents need to be emptied in a trash bag for obvious reasons. Second, the aluminum boat using the 9hp motor was left tied to the Lee Island dock close to the shore line and with the motor in the down position. The boat filled with water after two weeks of rain fall and the weight of the water nearly sank the boat and ground the lower unit on the motor into the sandy bottom of the lake. If extended time away from the islands is necessary, all the boats should be pulled to shore and the 9hp motor should always be left in an “up” position. The canoes have always been turned upside down which works well.

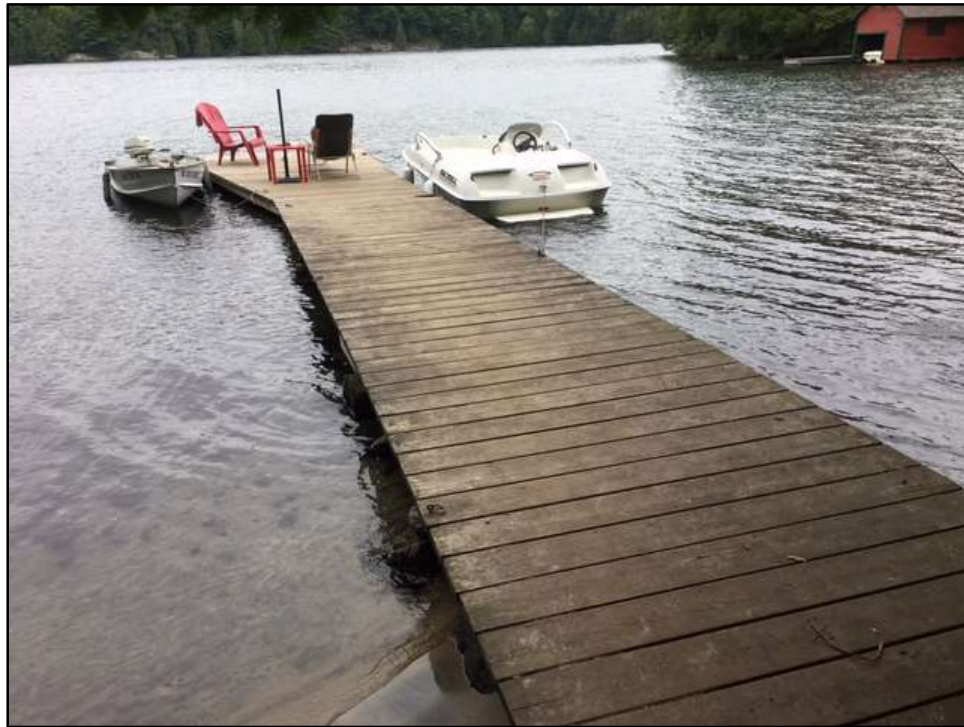
Main dock on Lee Island level and dead straight in August.

The main dock used to secure boats on Lee Island was in poor condition upon arrival in June. Lake levels were up and water was over the end of the dock which was nearly floating. One of the beams in the crib had detached itself from the structure and several rocks slipped from the containment. This is an easily rectified problem in the summer months but a little cold to tackle in early June. Me and the boys were able to level and replace the problem beam in August with very little effort. This dock was dead straight and level when we left in October but the ice will likely undo our work over the winter. I wouldn't say replacement is dire but time is short before a major overhaul is needed...probably within the next five years.

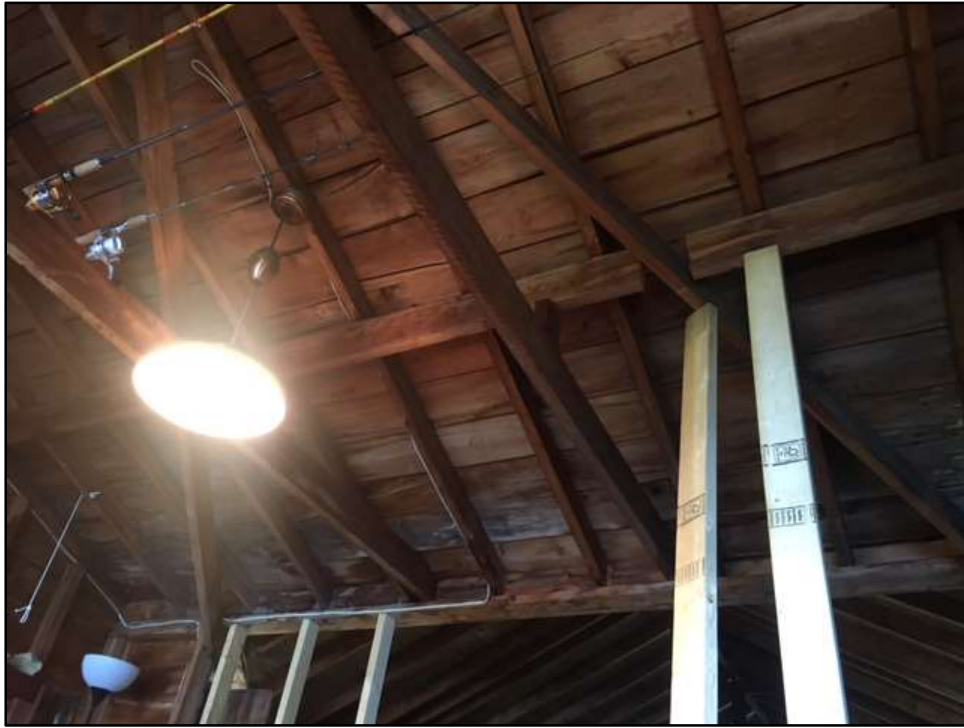
Last October, 2016, the Little House was showing significant signs of stress with sagging beams and structural supports pulled away from the wall. An accumulation of old age, the additional weight of new roof on the building and poor construction were the likely culprits. From what I can surmise, when the addition was being built a portion of the outside wall on the original cottage was cut away for an unobstructed view from the new kitchen to the old living room. This section of the outside wall was a structural wall and was not subsequently supported by a header. Only diagonal bracing ties the two structures together. For demonstration, imagine this scenario; a 10 foot long 2x4 plank is sitting on its side between two saw horses and you decide to sit in the middle of the board. The board bends and ultimately breaks from the weight. Now, imagine that same scenario except the 10 foot long board is now on its edge. The 2x4 is exponentially stronger in this orientation and will easily support your weight and much more. That's how a header is designed to work. Unfortunately, that's not how the outside wall was supported after it was removed. To make matters worse, the diagonal bracing inexplicitly cuts through the path of a support rafter secured into the stone chimney eliminating any load bearing capacity of this girder. This arrangement somehow lasted for 50 years before showing major signs of wear. Water penetration and carpenter ant damage, prior to replacing the roof, all took a toll on this structure that was also exacerbated by a 25% weight increase incurred from using premium shingles on the replacement roof.

The original truss system “supporting” the roof. A failure in so many ways.

To make a very long story short, the diagonal beams were removed, the support rafter embedded in the chimney was replaced, and two load bearing walls were constructed to support the original outside wall. A header could not be established above the large living room opening but one was constructed over the open "closet" area adjacent to the fireplace, giving minor relief to the rafters. Ultimately, since this house doesn't even sit on a foundation, it is difficult to determine what loads should even be addressed. I did the best I could and was able to recycle most of the removed lumber to the new support system. Hopefully it is in better shape to survive the heavy snow loads of the long Canadian winters.

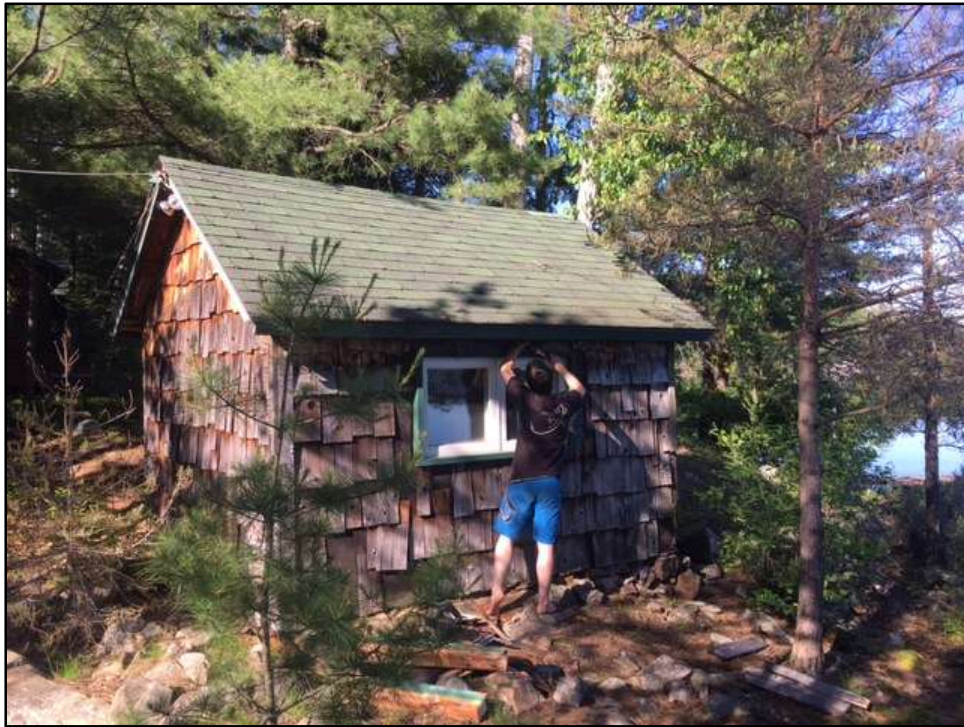
Ryan working on guest house window install. This is the biggest improvement to this structure in 85 years.

Progress continued on the Birch Lee guest cottage with the addition of a large awning window replacing a very small and inadequate single hung window. This was a pretty straight forward installation that exceedingly transformed the comfort and living space of this area. The entire room was vacuumed clean and prepped for electrical work. The new sub-floor held up well over the winter with no indication of intrusion by four legged critters.
